# Pipestone Lake Improvement Study and Management Plan

## Berrien County, Michigan

**Provided for: Pipestone Lake Association Board**

**Prepared by: Restorative Lake Sciences  
Dr. Jennifer L. Jermalowicz-Jones, CLP, CLM  
Water Resources Director  
[www.restorativelakesciences.com](http://www.restorativelakesciences.com)**

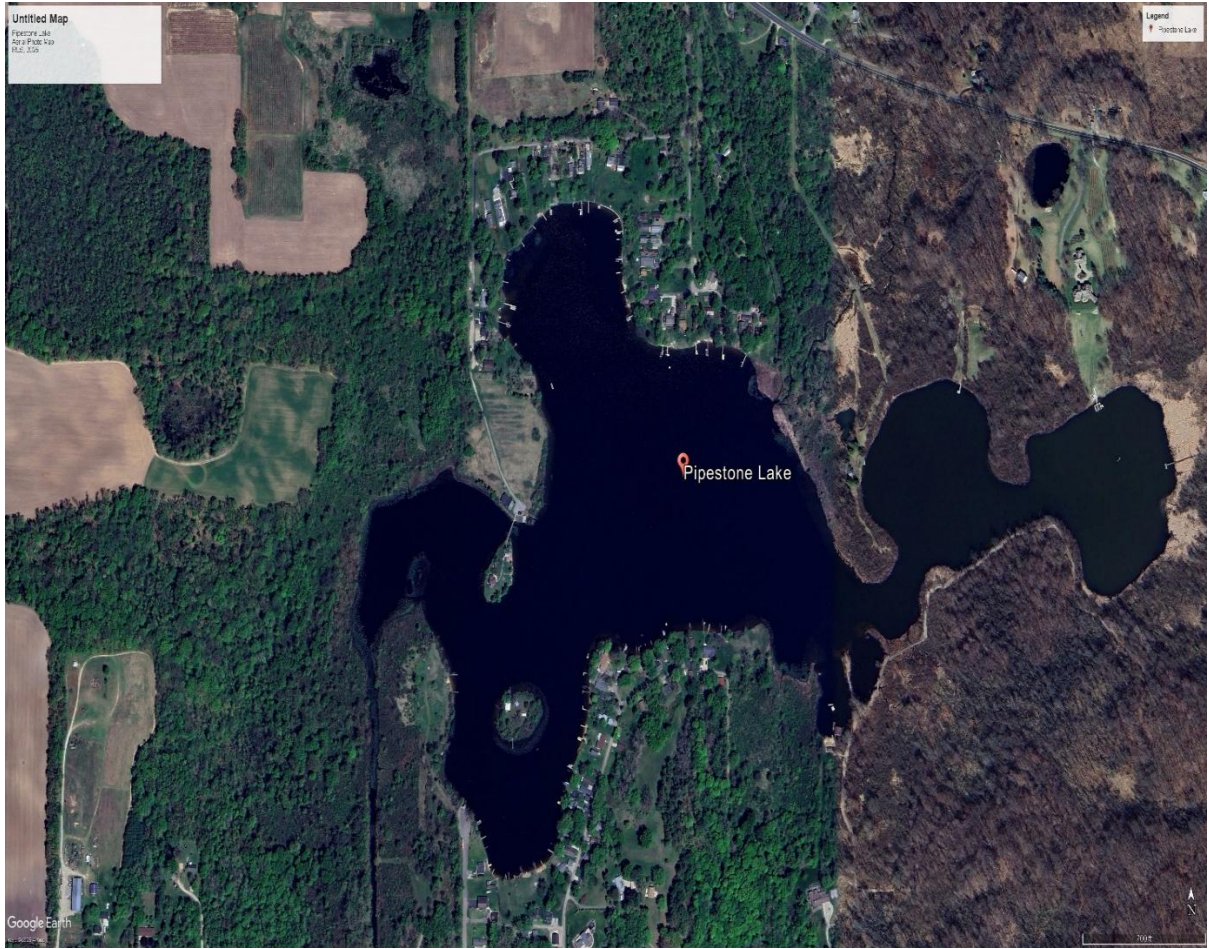
**Figure 1. Pipestone Lake Aerial Photo, Berrien County, Michigan.**

Pipestone Lake is located in Bainbridge Township in Berrien County, Michigan (Figure 1). The lake is comprised of 114.1 acres (RLS, 2025). The lake has five areas of water inflow and thus is considered a drainage lake that receives the majority of its water from surface waters, but it may also contain deeper springs.

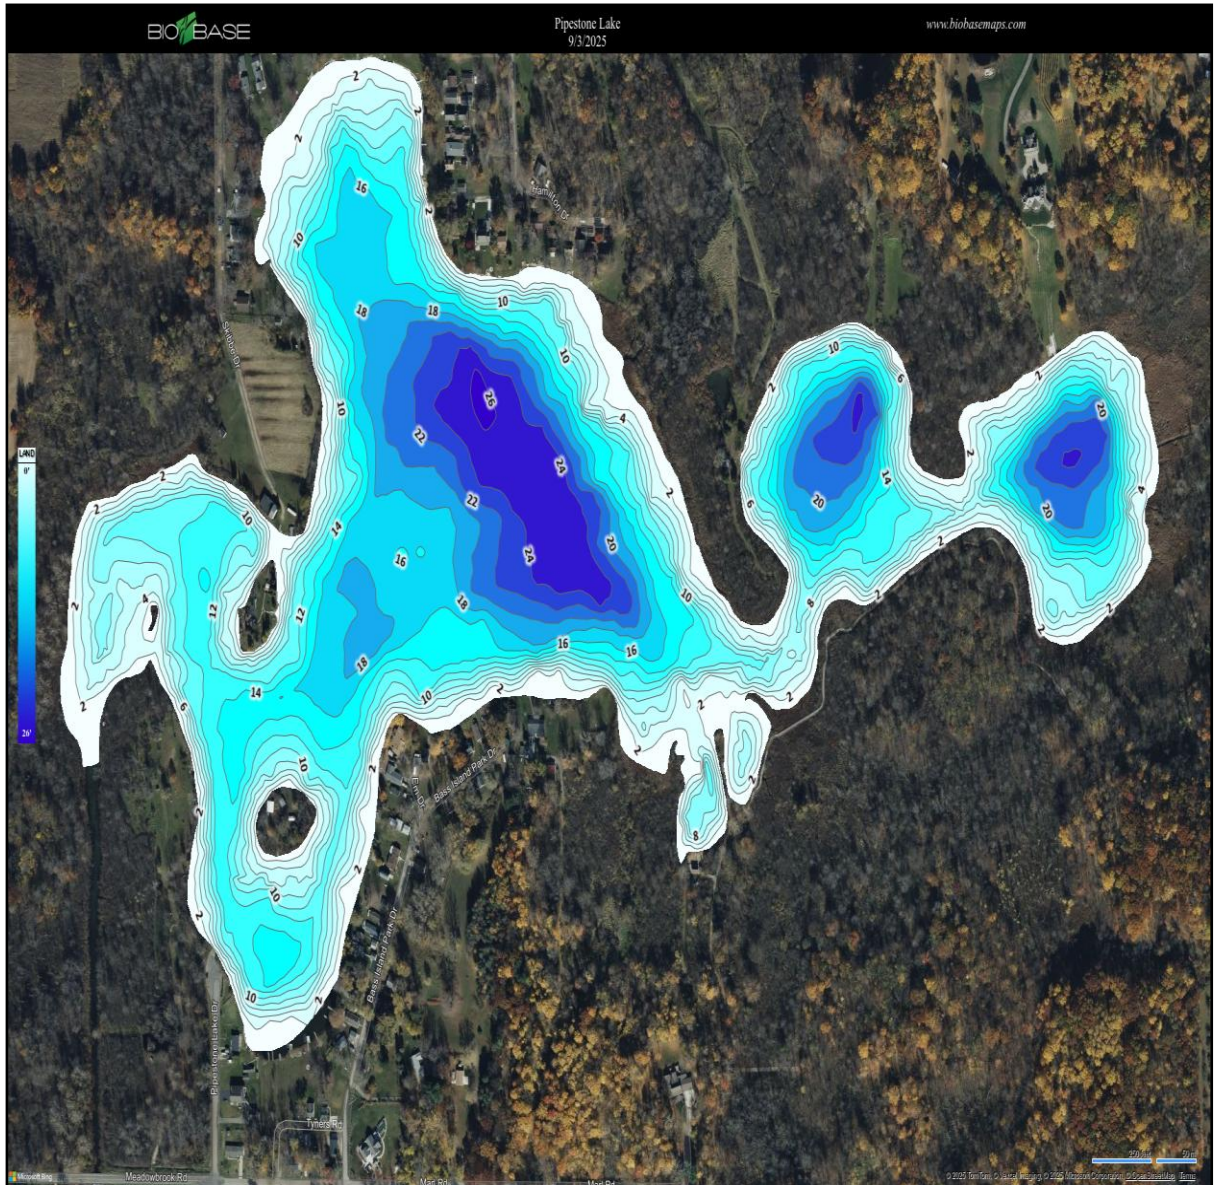
**Figure 2. Pipestone Lake Depth Contour Map, Berrien County, Michigan (September 3, 2025).**

The mean depth of the lake is approximately 13.2 feet, and the maximum depth is approximately 26.5 feet (RLS, 2025 bathymetric scan data; Figure 2). The lake also has a fetch (longest distance across the lake) of around 0.5 miles (RLS, 2025), and a shoreline length of 3.8 miles without the island shoreline included and 4.0 miles with the shoreline length included. Pipestone Lake has an approximate water volume of 1,369 acre-feet (RLS, 2025 bathymetric data).

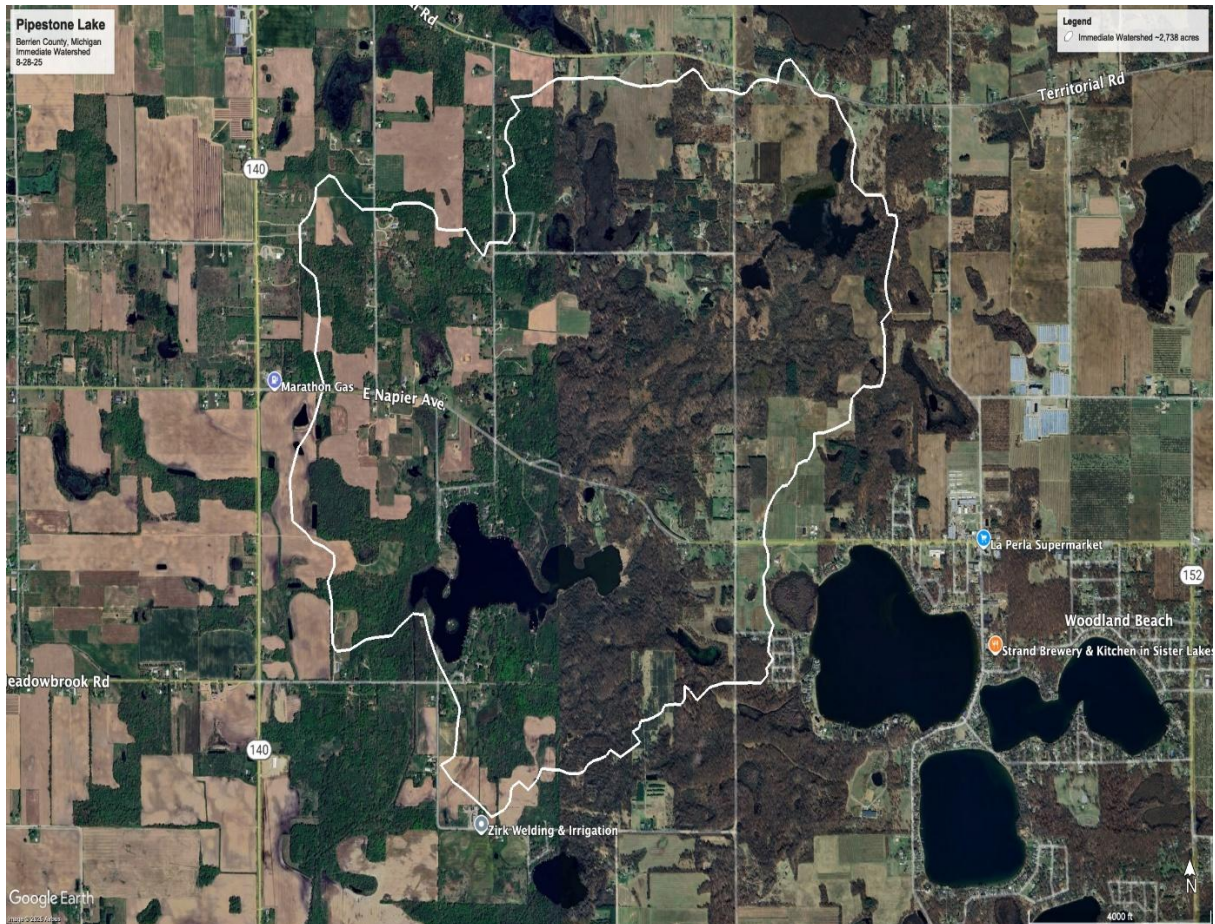
**Figure 3. Immediate Watershed draining into Pipestone Lake, Berrien County, Michigan (Restorative Lake Sciences, 2025).**

The immediate watershed of Pipestone Lake consists of the area around the lake that potentially directly drains to the lake and measures approximately 2,738 acres in size (Figure 3; RLS, 2025). The immediate watershed is about 24 times the size of the lake, which is considered a large-sized immediate watershed. The lakefront itself has a diverse application of land uses such as riparian waterfront, wetlands, and forested lands. Thus, management options should also consider all of these land uses and preserve their unique functions. Although erosion with high slopes is not an issue around the lake, ponding with abundant mucky soils is a potential issue for nutrient inputs. Best Management Practices (BMP's) for water quality protection are offered in the watershed improvement section of this report.

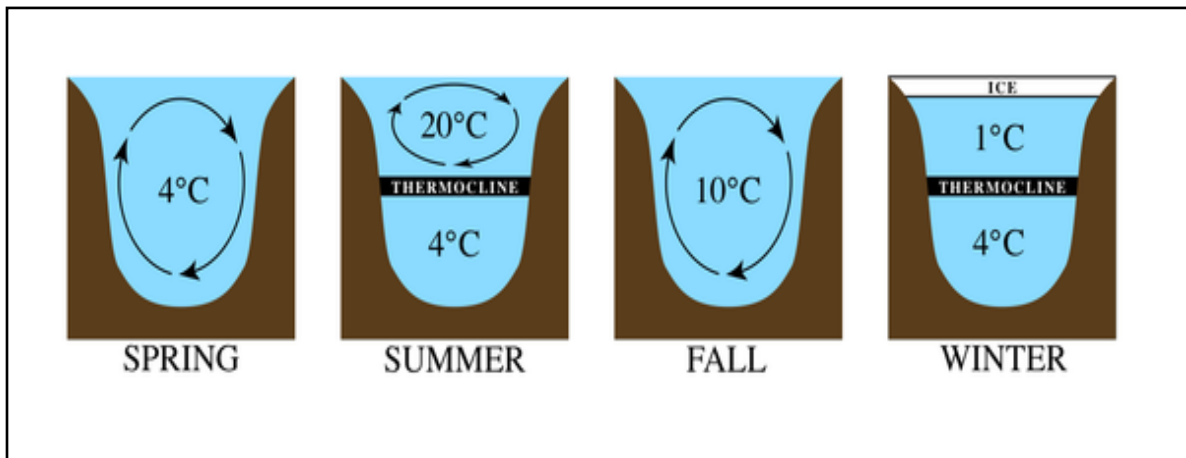
**Figure 7. The lake thermal stratification process.**

A lake's water temperature varies within and among seasons and is nearly uniform with depth under the winter ice cover because lake mixing is reduced when waters are not exposed to the wind. When the upper layers of water begin to warm in the spring after ice-off, the colder, dense layers remain at the bottom. This process results in a "thermocline" that acts as a transition layer between warmer and colder water layers. During the fall season, the upper layers begin to cool and become denser than the warmer layers, causing an inversion known as "fall turnover" (Figure 7). In general, shallow lakes will not stratify and deeper lakes may experience single or multiple turnover cycles. Water temperature was measured in degrees Celsius ( $^{\circ}\text{C}$ ) with the use of a calibrated Eureka Manta II<sup>®</sup> submersible thermometer. The September 3, 2025 water temperatures of Pipestone Lake demonstrated the presence of thermoclines and are indicative of a lake that mixes two times per year due to the presence of deep basins.

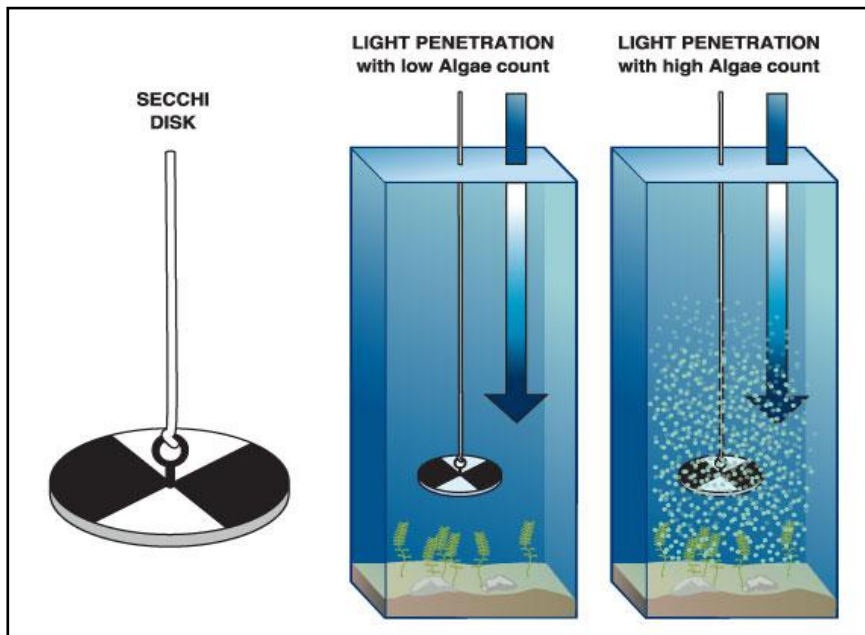
**Figure 8. Measurement of water transparency with a Secchi disk.**

Secchi transparency is a measure of the clarity or transparency of lake water, and is measured with the use of an 8-inch diameter standardized Secchi disk. Secchi disk transparency is measured in feet (ft.) or meters (m) by lowering the disk over the shaded side of a boat around noon and taking the mean of the measurements of disappearance and reappearance of the disk (Figure 8). Elevated Secchi transparency readings allow for more aquatic plant and algae growth. Eutrophic systems generally have Secchi disk transparency measurements less than 7.5 feet due to turbidity caused by excessive planktonic algae growth. The Secchi transparency of Pipestone Lake was measured on September 3, 2025 and was 6.4 feet over the deep basins which are fair measurements. Measurements were collected during calm conditions.

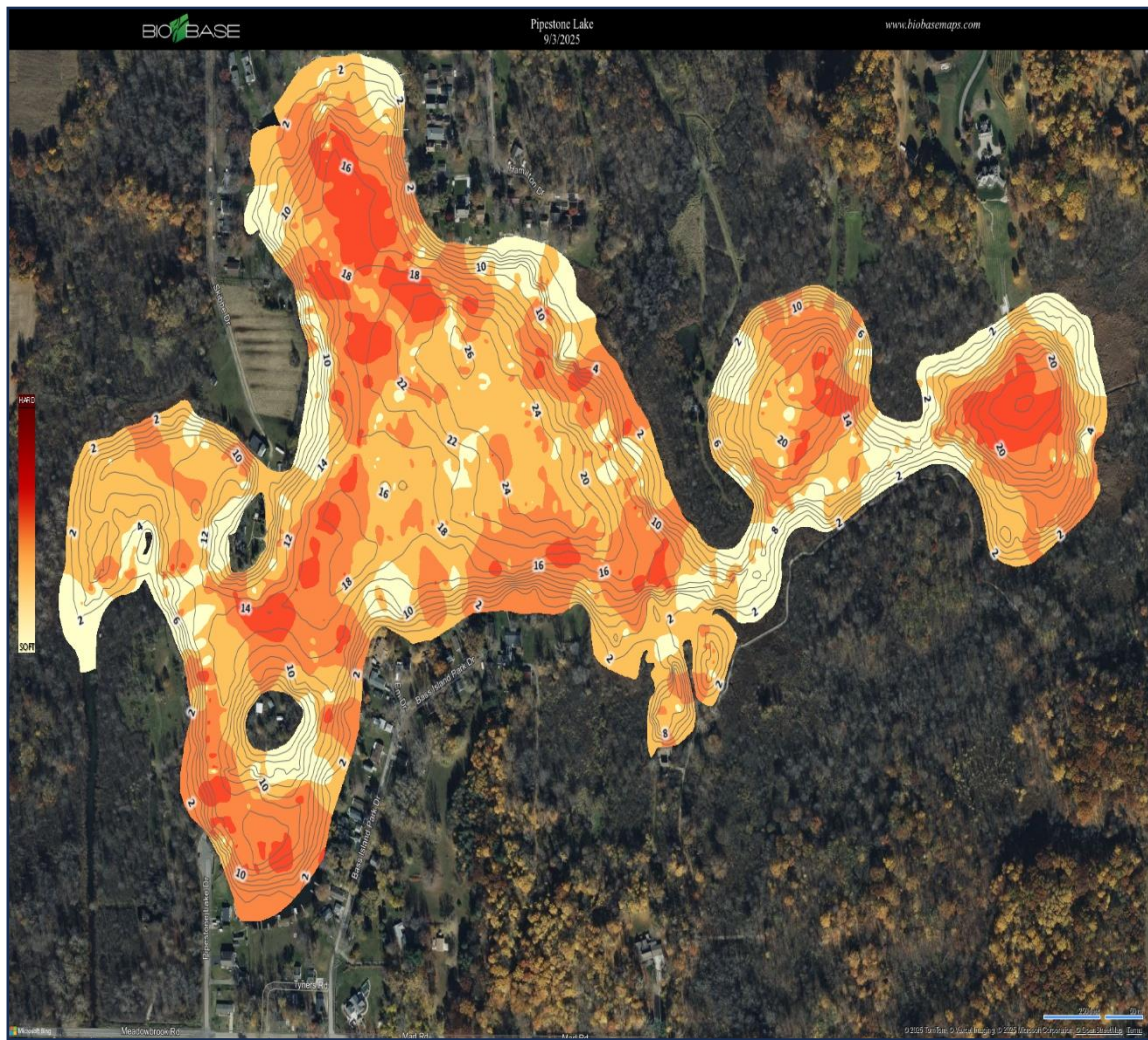
Figure 9. Pipestone Lake sediment relative hardness map. Note: The light colored areas represent less consolidated sediments, and the darker colors represent more consolidated sediments.

**Table 4. Pipestone Lake relative hardness of the lake bottom on September 3, 2025 by category or hardness and percent cover of each category (relative cover).**

<b>Lake Bottom Relative Hardness Category</b>	<b>% Relative Cover of Bottom by Category</b>
<b>0.0-0.1</b>	7.7
<b>0.1-0.2</b>	14.7
<b>0.2-0.3</b>	31.5
<b>0.3-0.4</b>	40.2
<b>&gt;0.4</b>	5.9

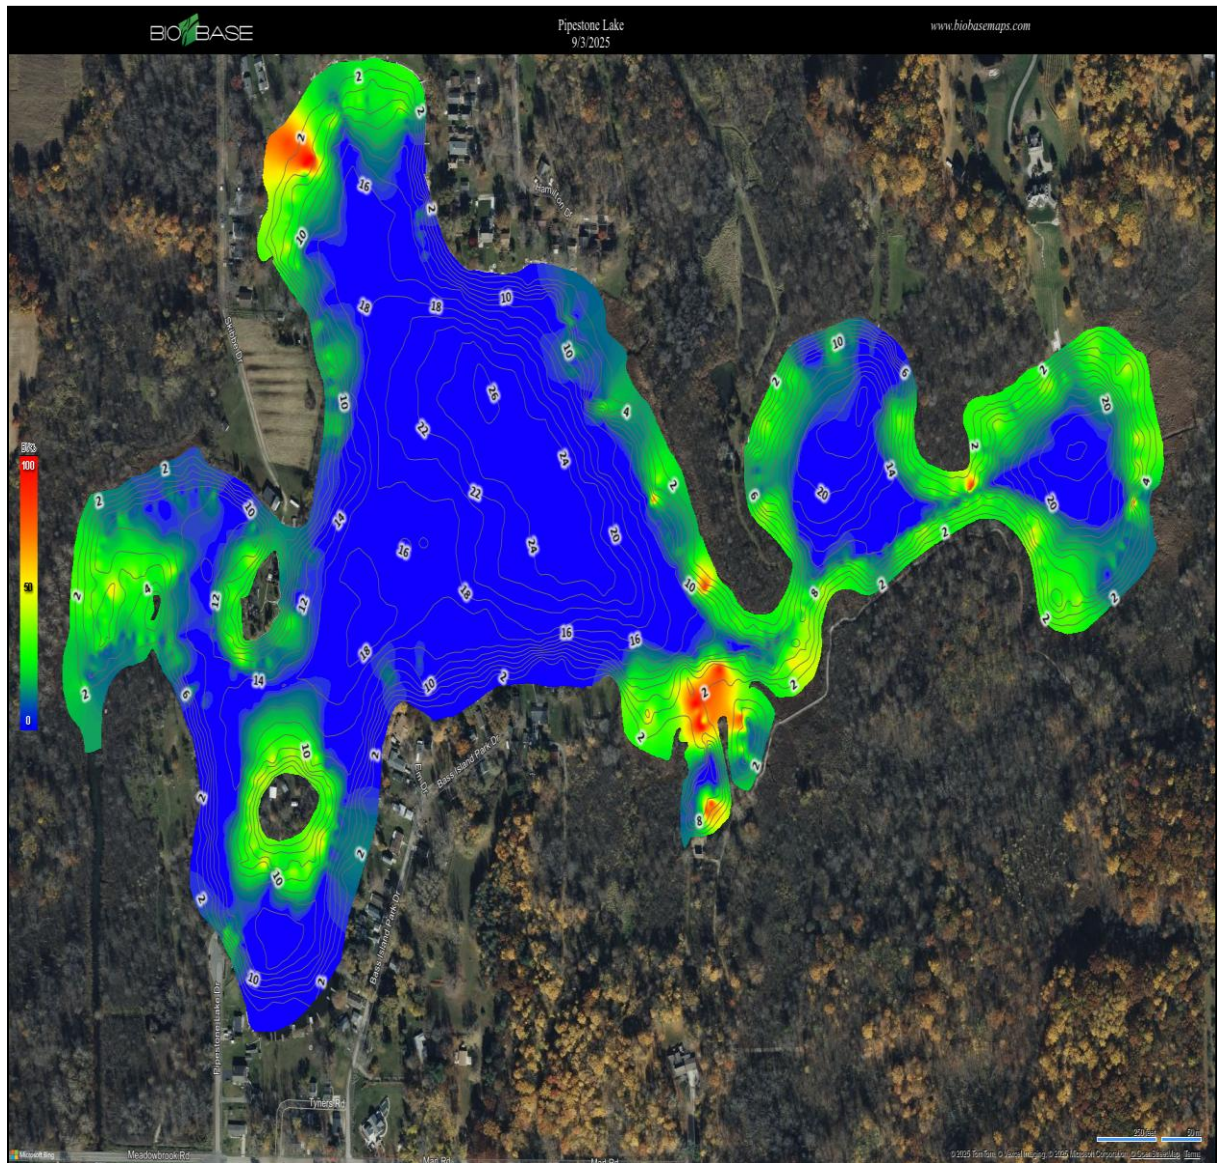
**Figure 10. Aquatic plant biovolume of all aquatic plants in Pipestone Lake, Pipestone County, Michigan (September 3, 2025). Note: Red denotes high-growing aquatic plants, green color denoted low-growing aquatic plants, and blue color represents a lack of aquatic vegetation.**

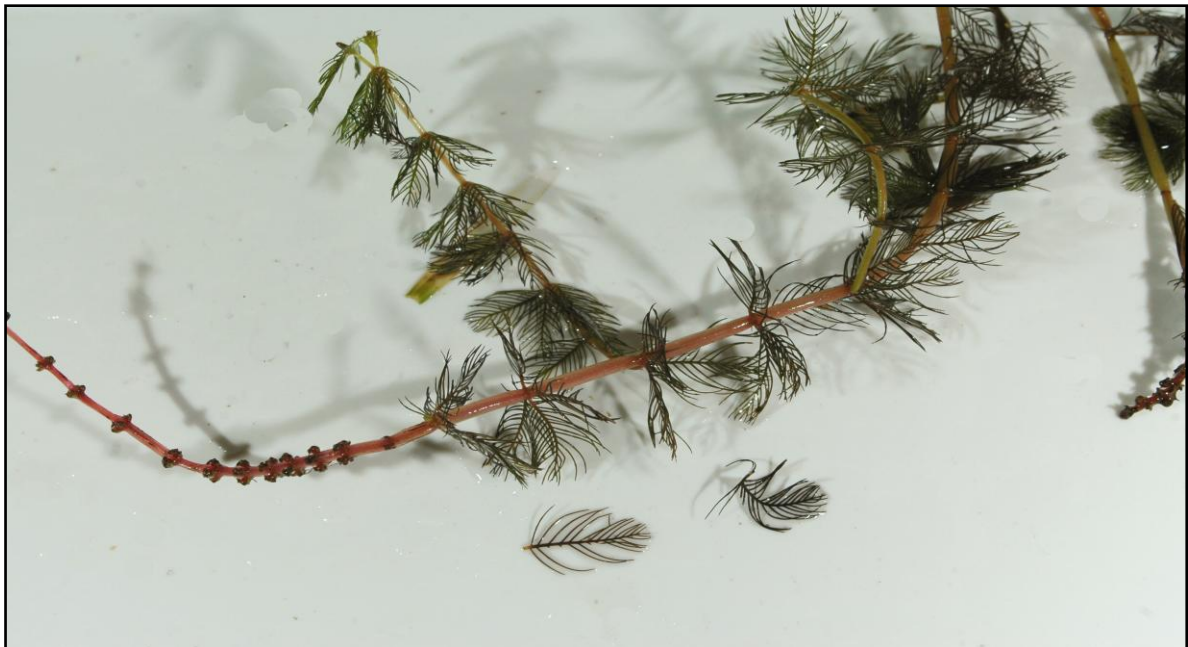
**Figure 30. Hybrid Eurasian Watermilfoil plant with seed head and fragments.**

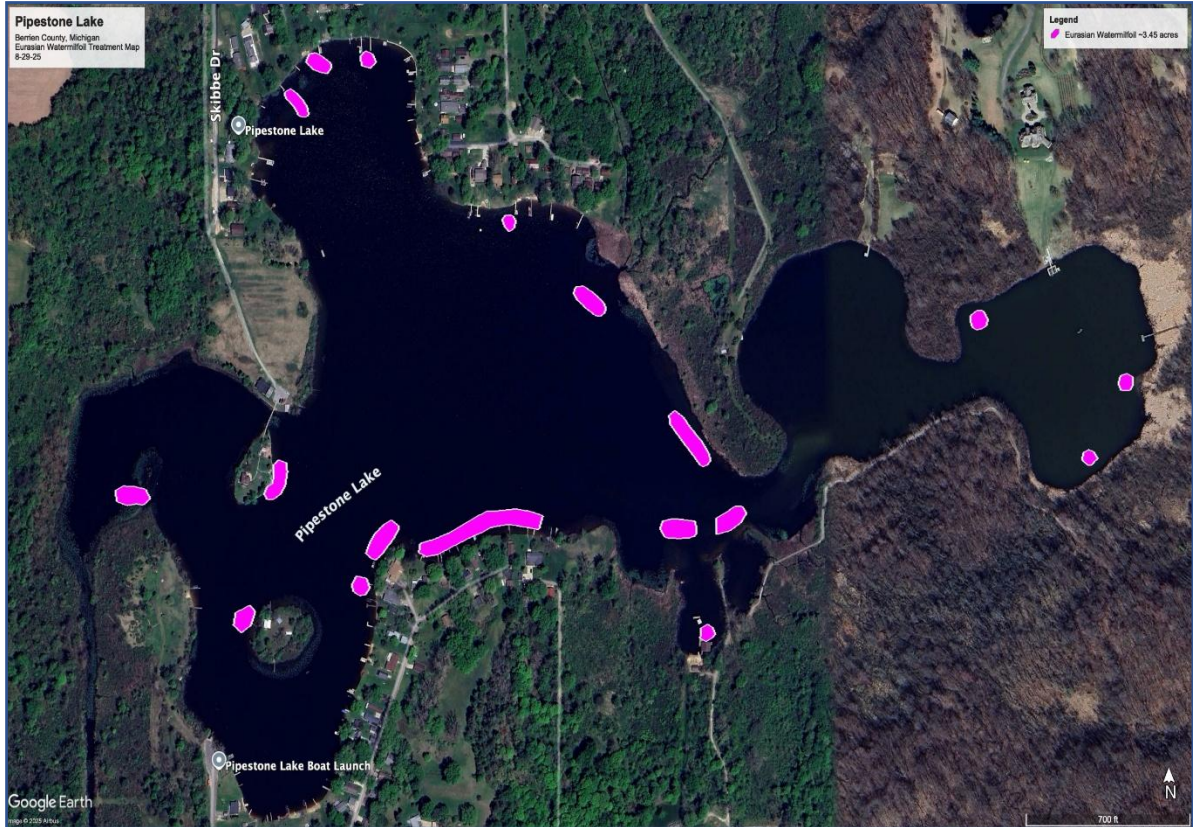
**Figure 31. EWM distribution in Pipestone Lake (August 28, 2025).**

Approximately 3.5 acres of Eurasian Watermilfoil were found in Pipestone Lake during the August 28, 2025 survey (Figure 31). A precise management program is proposed below. Eurasian Watermilfoil growth in Pipestone Lake is capable of producing dense surface canopies in shallow areas as well as in deeper waters due to the sometimes high light penetration. In addition, it could hybridize with native watermilfoils and create a highly herbicide-resistant strain.

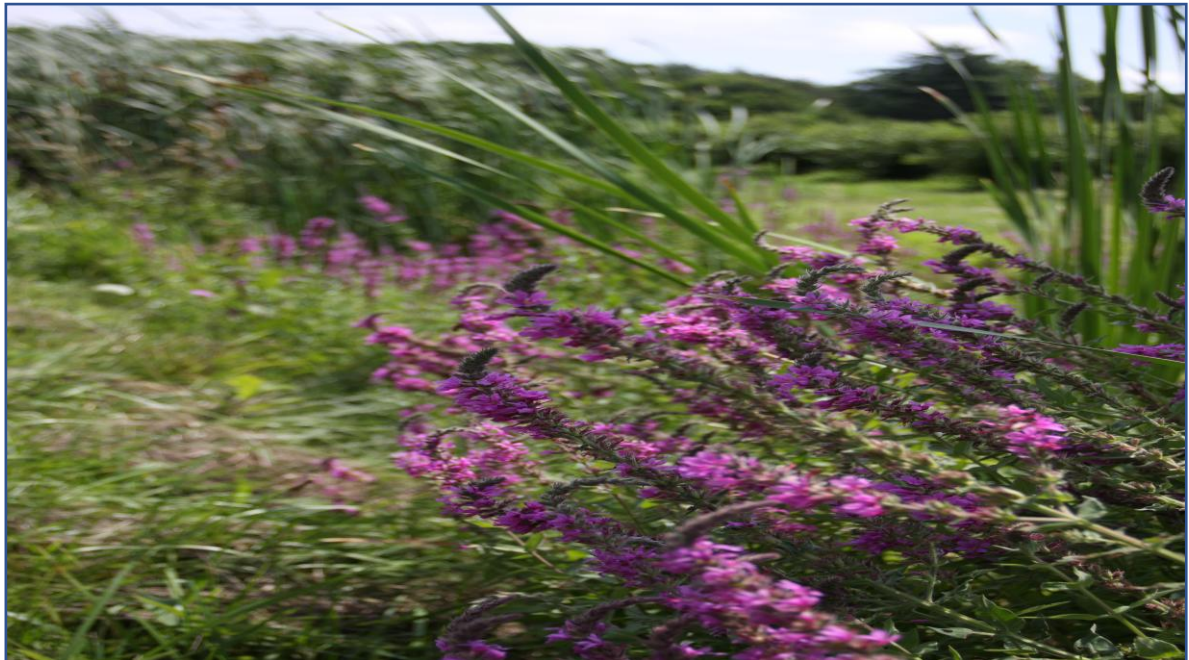
**Figure 32. The invasive emergent Purple Loosestrife (©RLS).**

Purple Loosestrife (*Lythrum salicaria*; Figure 32) is an invasive (i.e. exotic) emergent aquatic plant that inhabits wetlands and shoreline areas and was found in 32 locations (Figure 33) around the shoreline of Pipestone Lake. *L. salicaria* has showy magenta-colored flowers that bloom in mid-July and terminate in late September. The seeds are highly resistant to tough environmental conditions and may reside in the ground for extended periods of time. It exhibits rigorous growth and may out-compete other favorable native emergents such as Cattails (*Typha latifolia*) and thus reduce the biological diversity of localized ecosystems. The plant is spreading rapidly across the United States and is converting diverse wetland habitats to monocultures with substantially lower biological diversity. It should be removed promptly if found (i.e. by hand pulling or using a shovel to remove the roots and then discarding the plant into the garbage) to avoid further infestation.

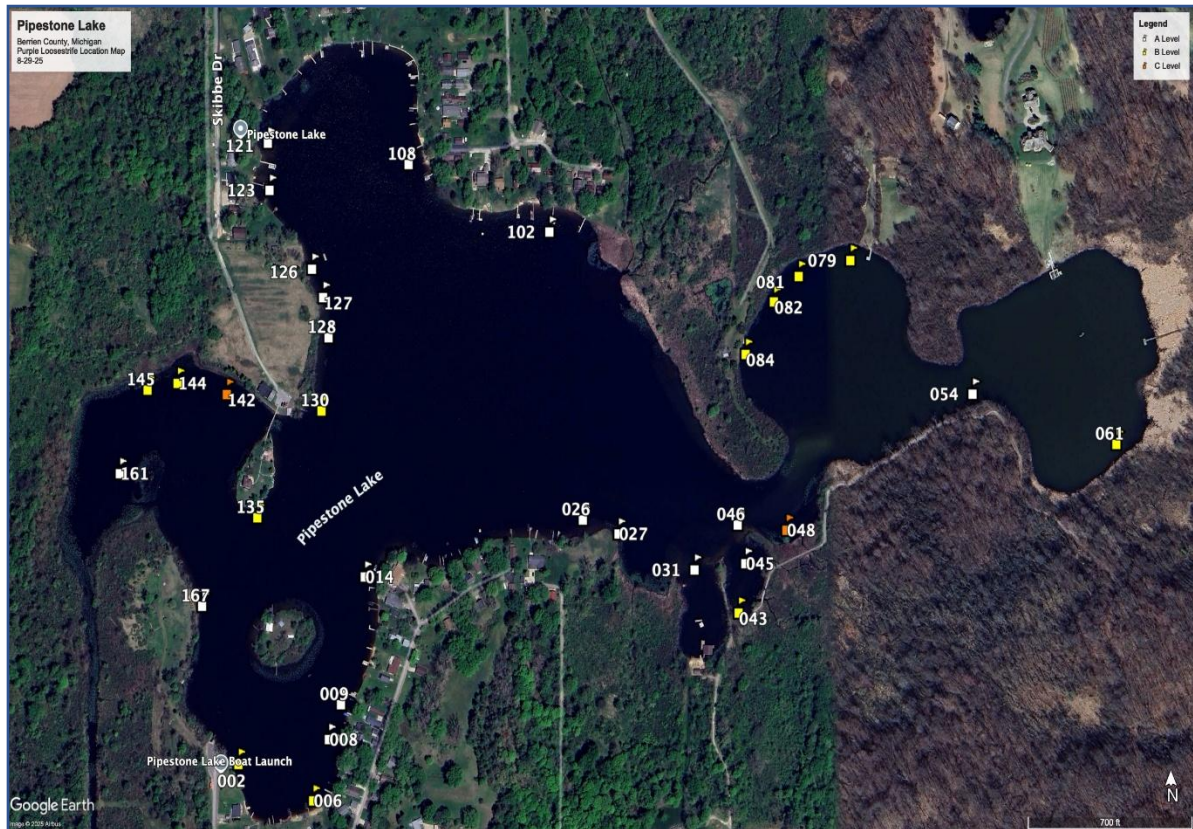
Figure 33. Purple Loosestrife distribution around Pipestone Lake (August 28, 2025).

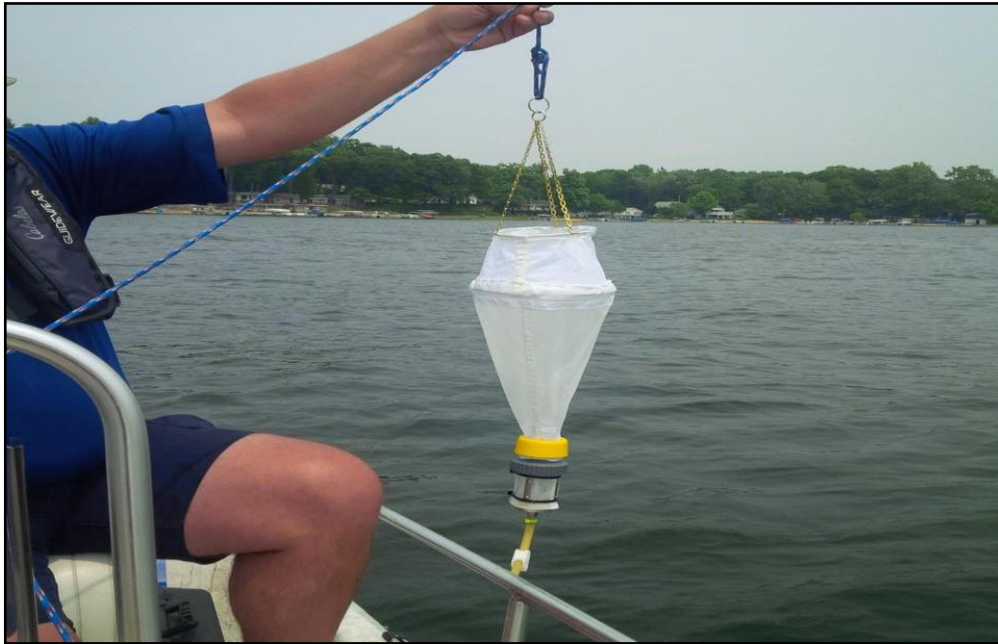
Figure 34. A zooplankton collection tow net.

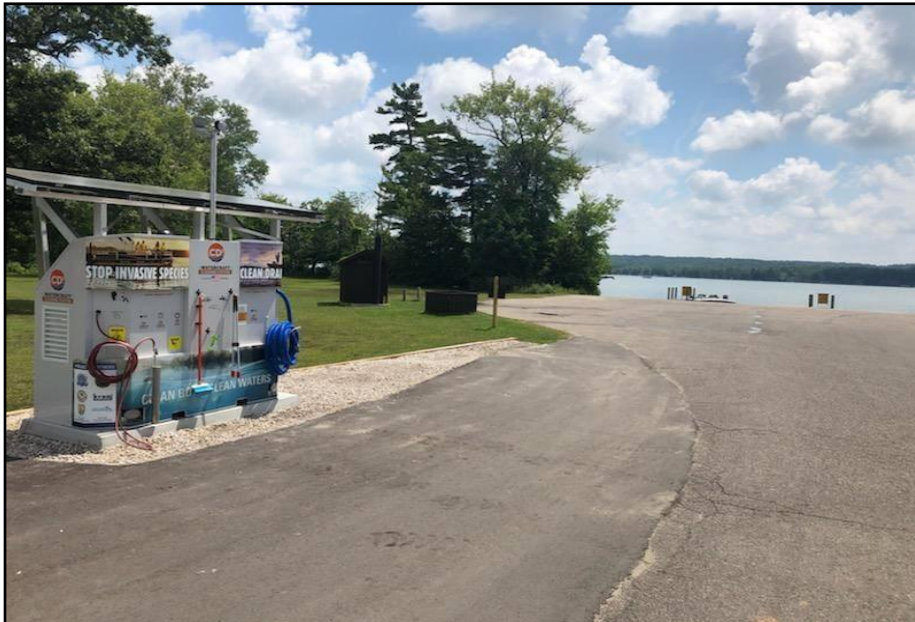
**Figure 37. A public boat washing station on Higgins Lake, Michigan.**

Recently, MSU partnered with EGLE to study the various forms of boat washing stations (including the innovative CD3 units) on lakes to analyze effectiveness of invasive removal, behavior patterns and preference for use, and short and long-term cost effectiveness of each system. This will assist in the placement of specific types of wash stations around specific portals of entry around lakes. Boat washing stations and invasive species prevention signs are recommended at all public entry sites where practical, especially since enforcement is not required and is lacking.

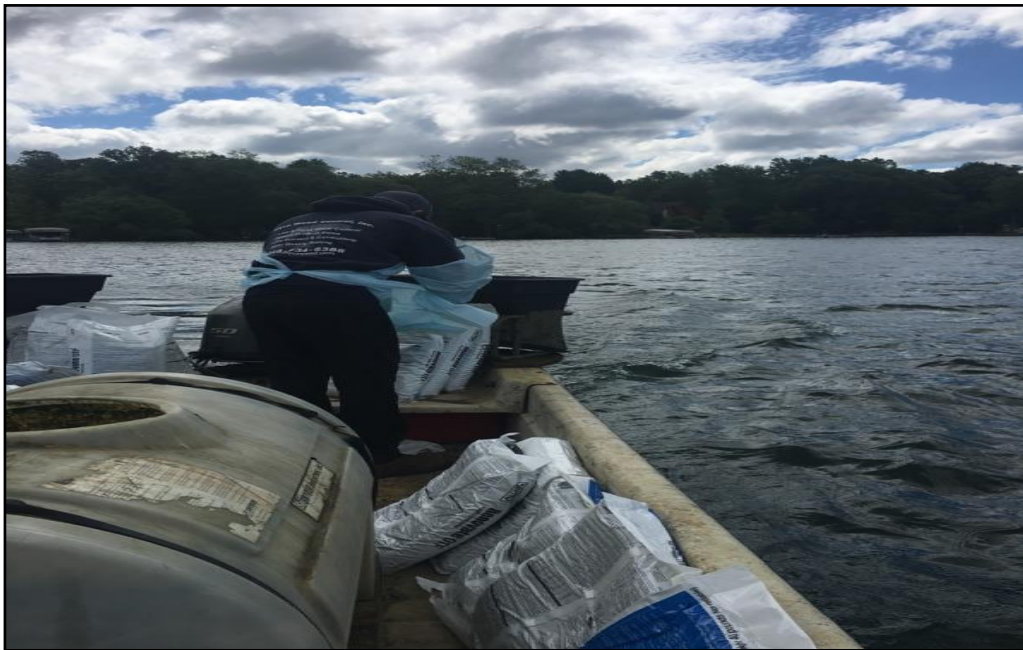
**Figure 42. A boat used to apply aquatic herbicides in inland lakes.**

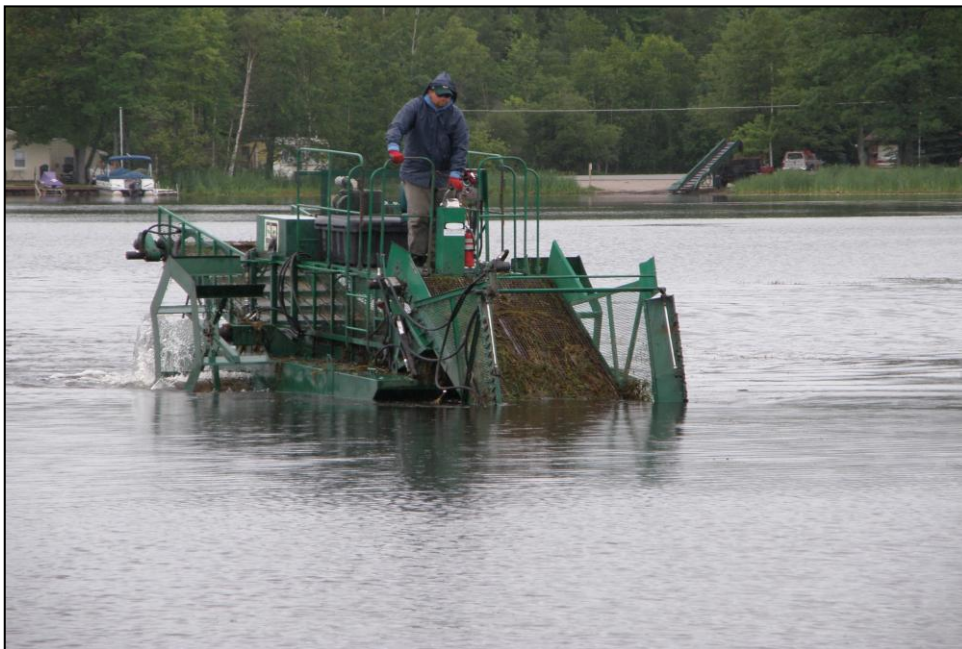
**Figure 43. A mechanical harvester used to remove aquatic plants.**

Mechanical harvesting is usually not recommended for the removal of Eurasian Watermilfoil since the plant may fragment when cut and re-grow on the lake bottom. Due to the distribution of invasives in open water areas, mechanical harvesting is not recommended or needed for Pipestone Lake at this time. It may, however, be used to remove dense lily pad biomass in beach areas as an alternative to the use of herbicides.

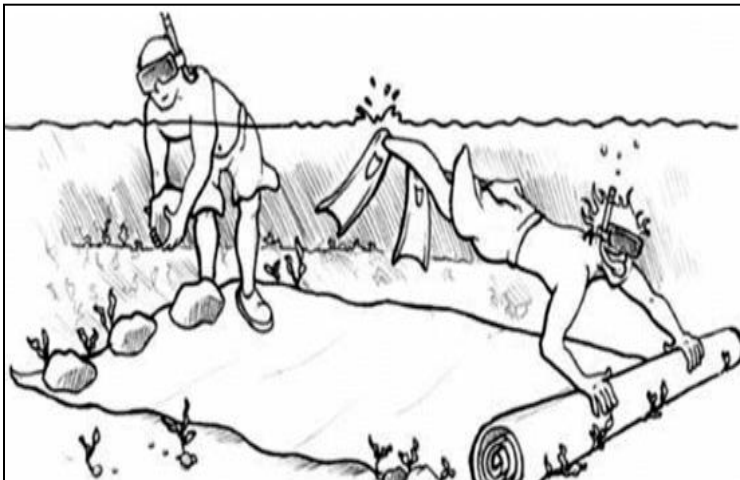
Figure 44. A Benthic Barrier. Photo courtesy of Cornell Cooperative Extension.

They are anchored to the lake bottom to avoid becoming a navigation hazard. The cost of the barriers varies among vendors but can range from \$100-\$1,000 per mat. Benthic barrier mats can be purchased online at: [www.lakemat.com](http://www.lakemat.com) or [www.lakebottomblanket.com](http://www.lakebottomblanket.com). The efficacy of benthic barrier mats has been studied by Laitala et al. (2012) who report a minimum of 75% reduction in invasive milfoil in the treatment areas. Lastly, benthic barrier mats should not be placed in areas where fishery spawning habitat is present and/or spawning activity is occurring.

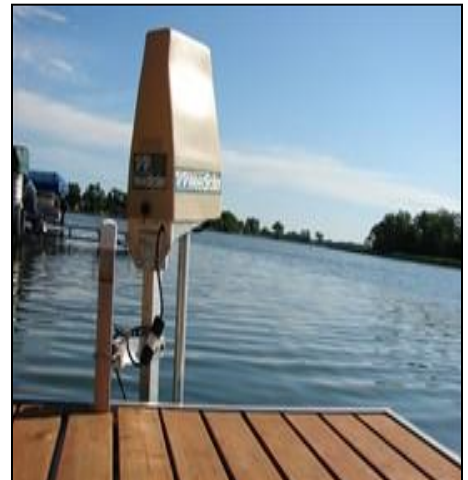
Figure 45. A Weed Roller.

Weed Rollers are electrical devices which utilize a rolling arm that rolls along the lake bottom in small areas (usually not more than 50 feet) and pulverizes the lake bottom to reduce germination of any aquatic vegetation in that area. They can be purchased online at: [www.crary.com/marine](http://www.crary.com/marine) or at: [www.lakegroomer.net](http://www.lakegroomer.net). Both methods are useful in recreational lakes such as Pipestone Lake and work best in beach areas and near docks to reduce nuisance aquatic vegetation growth if it becomes prevalent in future years.

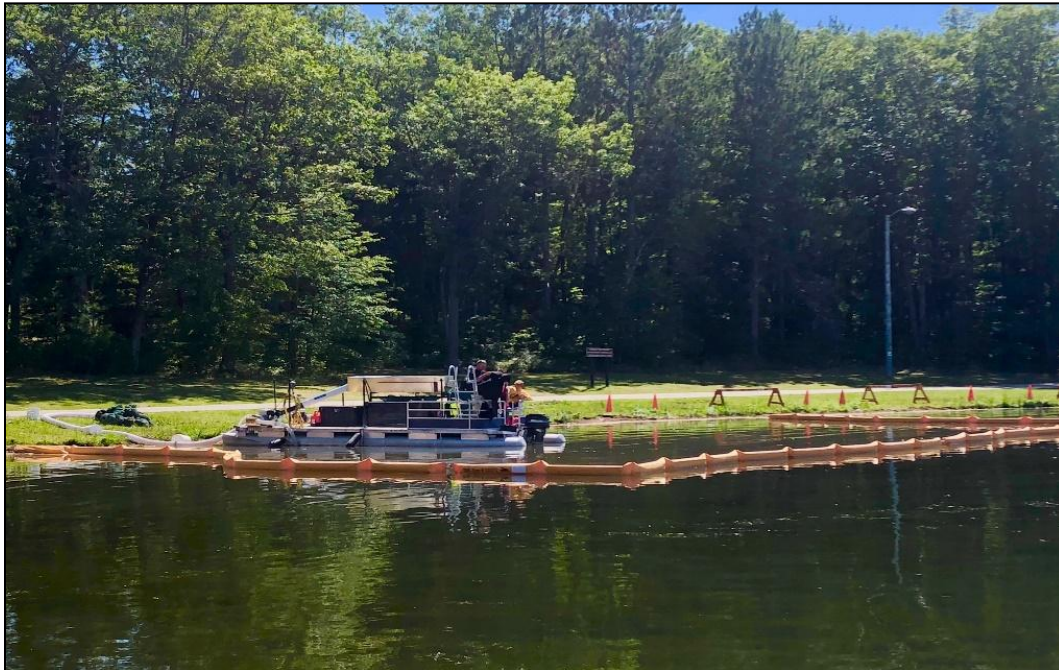
**Figure 46. A DASH boat used in a lake for aquatic plant removal.**

Because this activity may cause re-suspension of sediments (Nayar et al., 2007), increased turbidity and reduced clarity of the water can occur. Permitting requirements include the use of a turbidity curtain that reduce the transport of solids to locations outside of treatment areas and also help define areas where intensive aquatic vegetation removal efforts are being implemented. This method may be feasible for small areas of dense lily pad removal and result in permanent reduction of them in DASH areas. It is however very costly and costs often range from \$1,500-\$4,000 per acre.

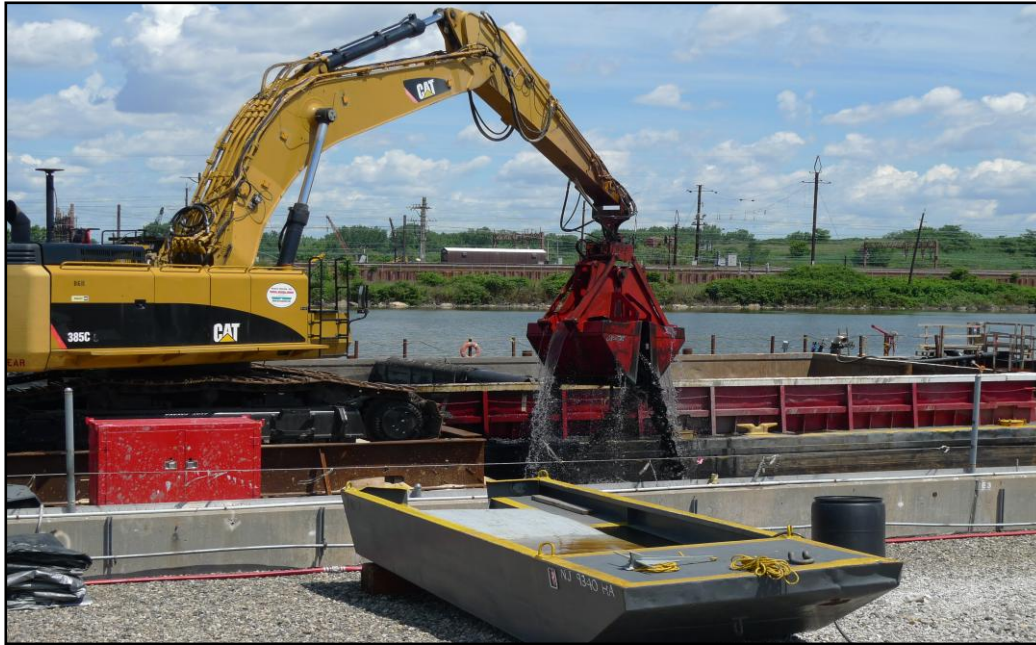
**Figure 47. A mechanical dredge for sediment removal in inland waters.**

Dredge spoils cannot usually be emptied into wetland habitats; therefore, a large upland area is needed for lakes that are surrounded by wetland habitats. Furthermore, this activity may cause re-suspension of sediments (Nayar et al., 2007) which may lead to increased turbidity and reduced clarity of the water. In addition, proposed sediment for removal must be tested for metal contaminants before being stored in a CDF. Dredging is a very costly operation with an average dredging cost of \$28-40 per cubic yard. Dredging is not recommended for any areas in Pipestone Lake at this time but could be used in shallow bays in the future if the water level becomes too low or navigation becomes difficult.
